UNITED STATES ENVIRONMENTAL PROTECTION AGENCY

SUBJ: EPA Asbestos Removal at 320 Sloan Street

REMOVAL ACTION STATUS REPORT DAVIDSON ASBESTOS

Property Address: 320 Sloan Street Street, Davidson, Mecklenburg County, North Carolina

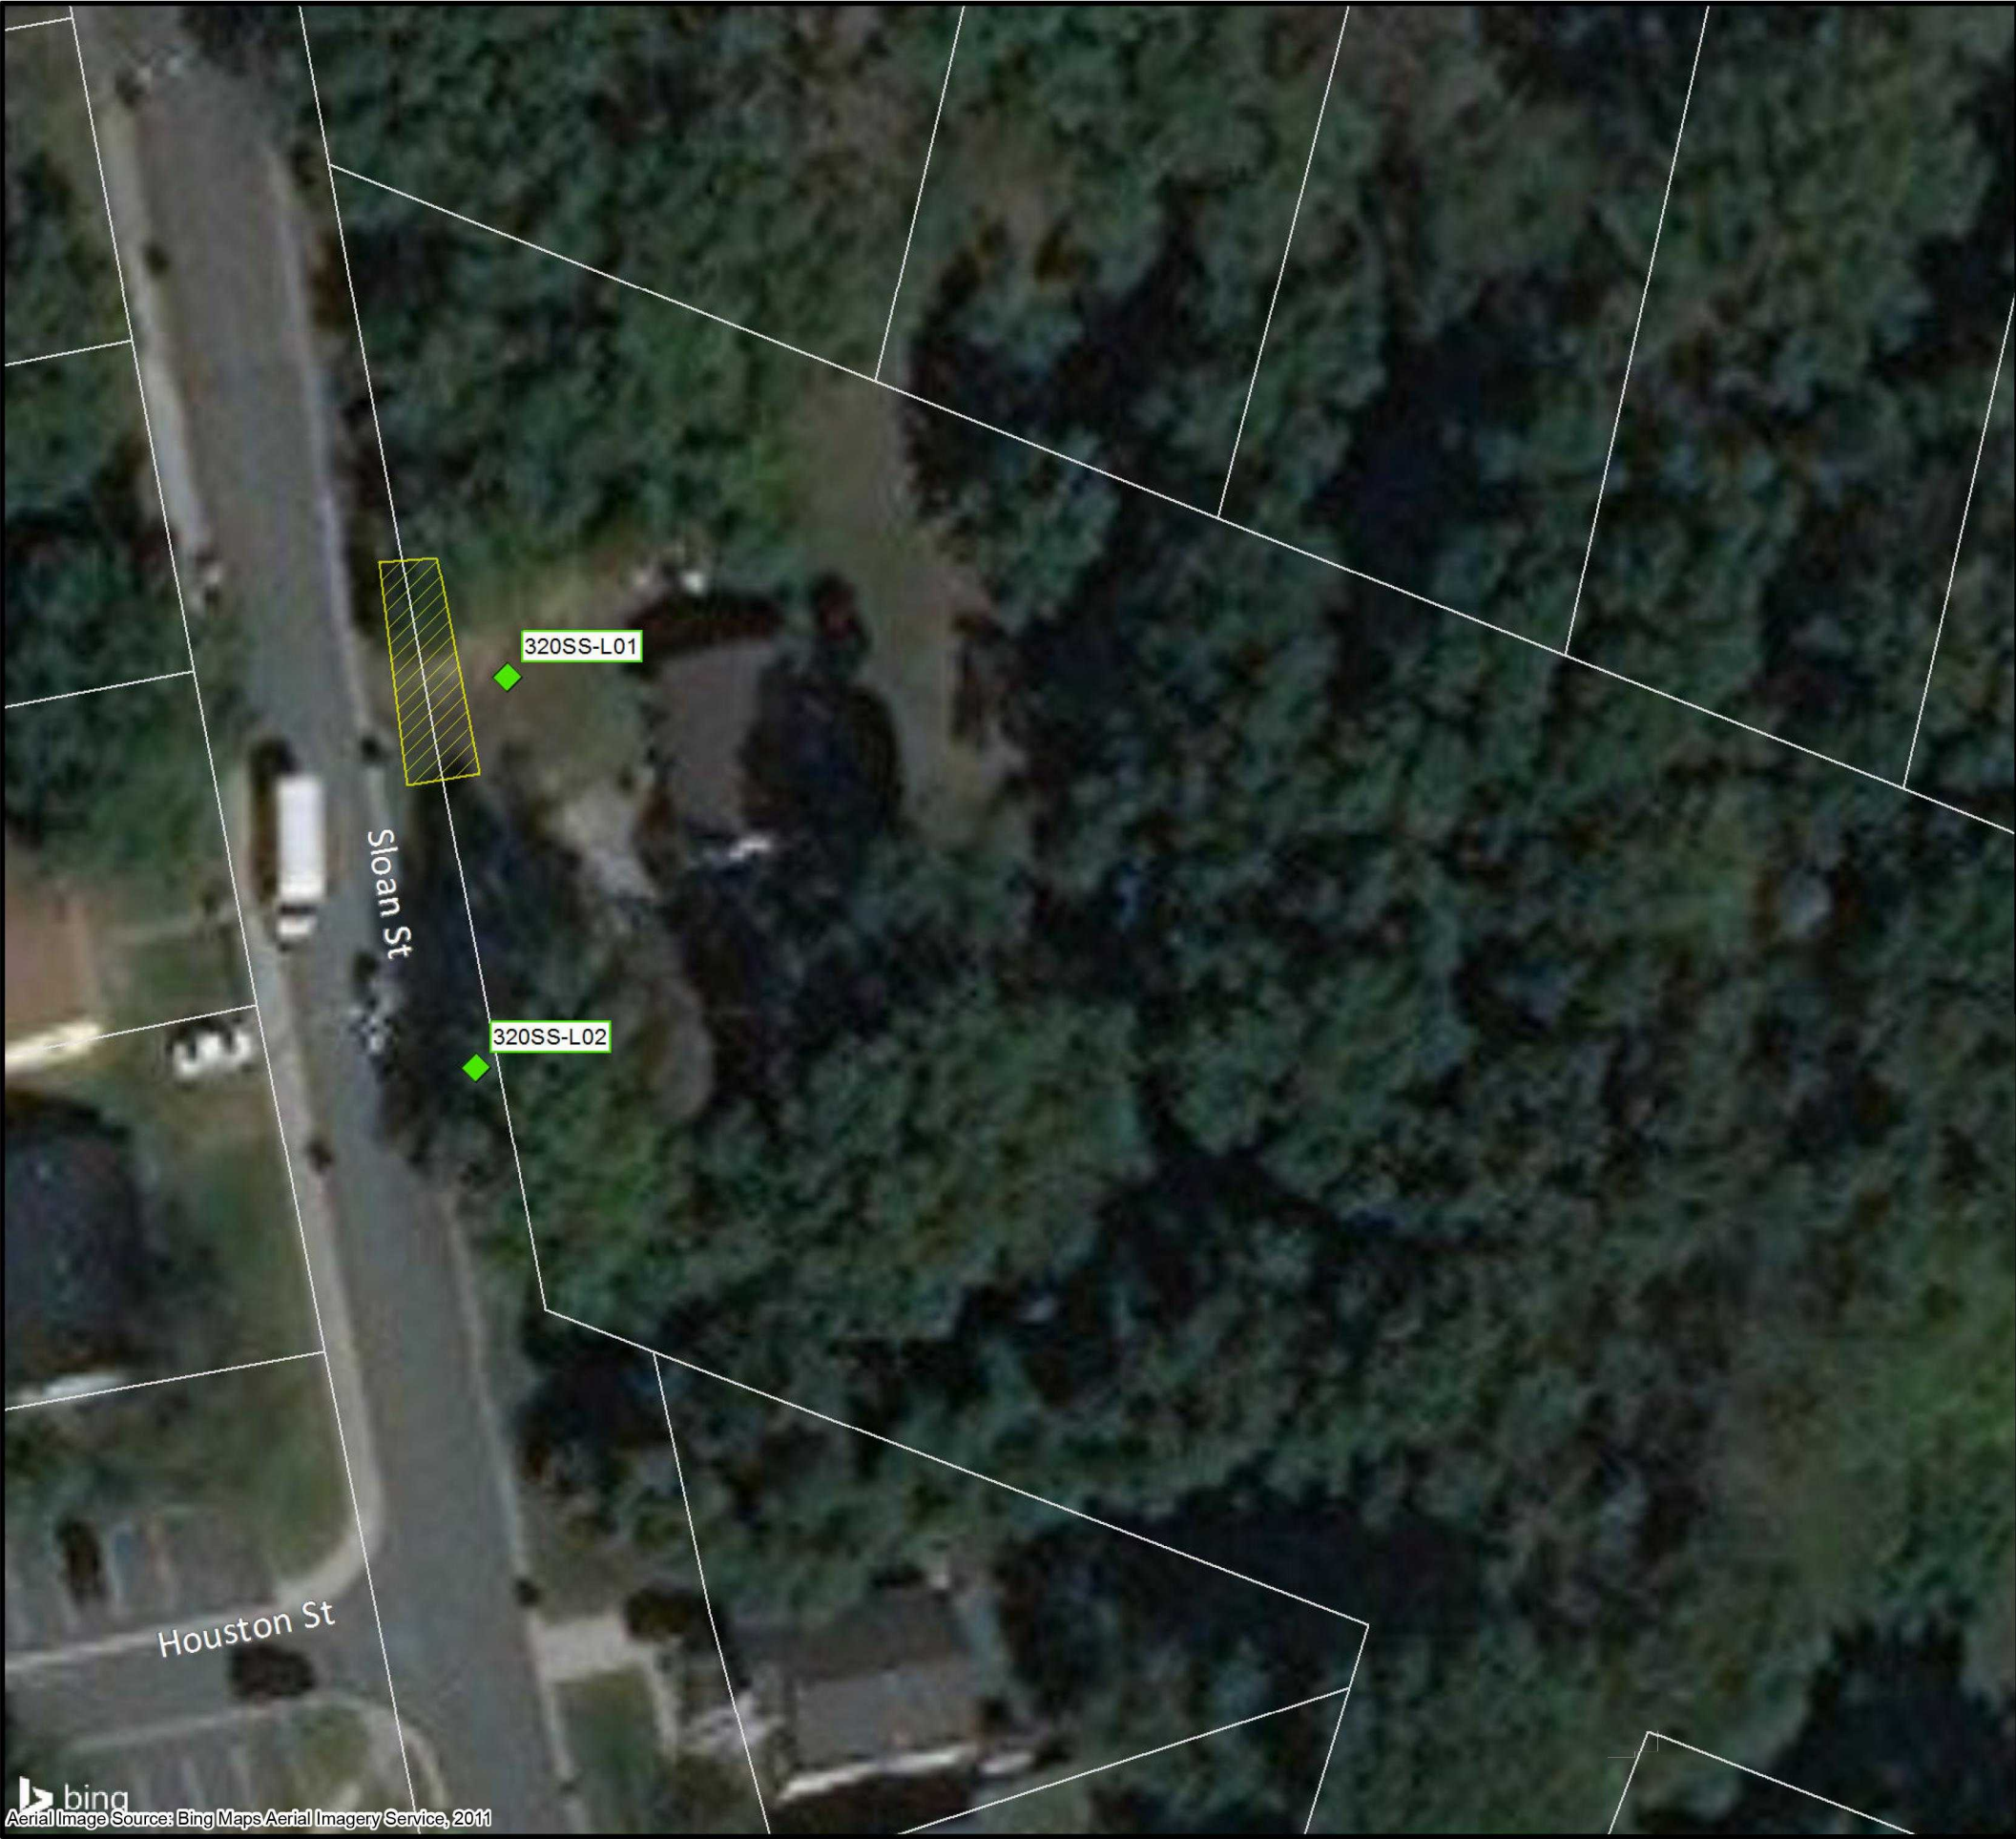
FIGURE 1
Removal Areas and
Air Sampling Locations

Description of Removal Action: The soil was excavated to an approximate maximum depth of 12 inches in the northwest portion of the front yard along Sloan Street (see Appendix 1). Visual inspections of the excavated areas for asbestos-containing materials (ACM) were conducted by a State of North Carolina-accredited asbestos inspector and air monitor. ACM was not visibly present in the excavated area and restoration activities were allowed to commence.

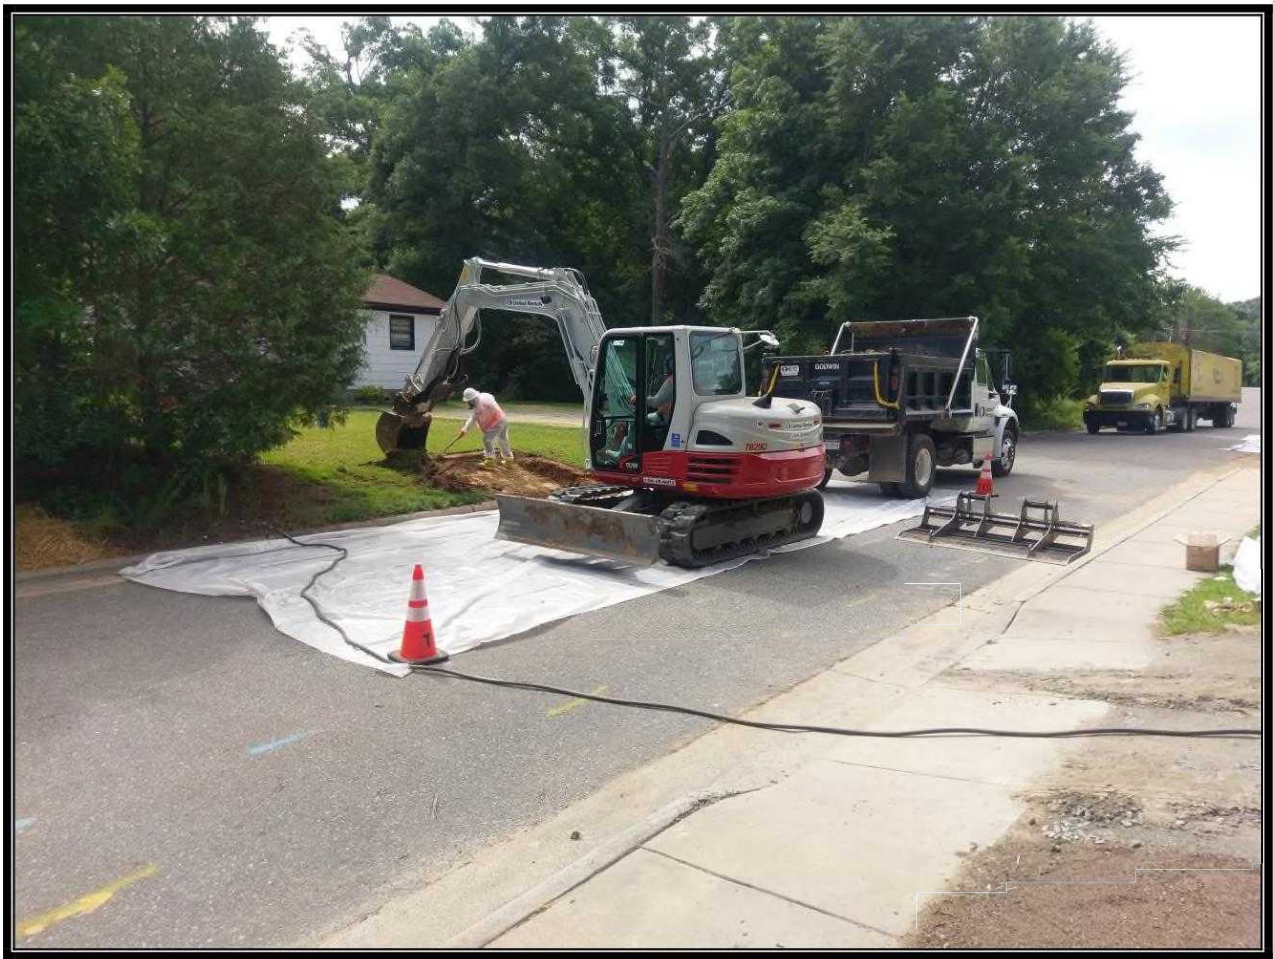
OFFICIAL PHOTOGRAPH NO. 1
U.S. ENVIRONMENTAL PROTECTION AGENCY

Subject: The Emergency and Rapid Response Services (ERRS) contractor, Environmental Restoration, LLC (ER), used an excavator and hand tools to remove asbestos-containing materials (ACM) and asbestos-contaminated soil from the property located at 320 Sloan Street. ER used hoses to wet the asbestos-contaminated soil and placed plastic sheeting under the dump trucks to prevent asbestos-contaminated soil from falling onto the sidewalk and the road during removal activities.

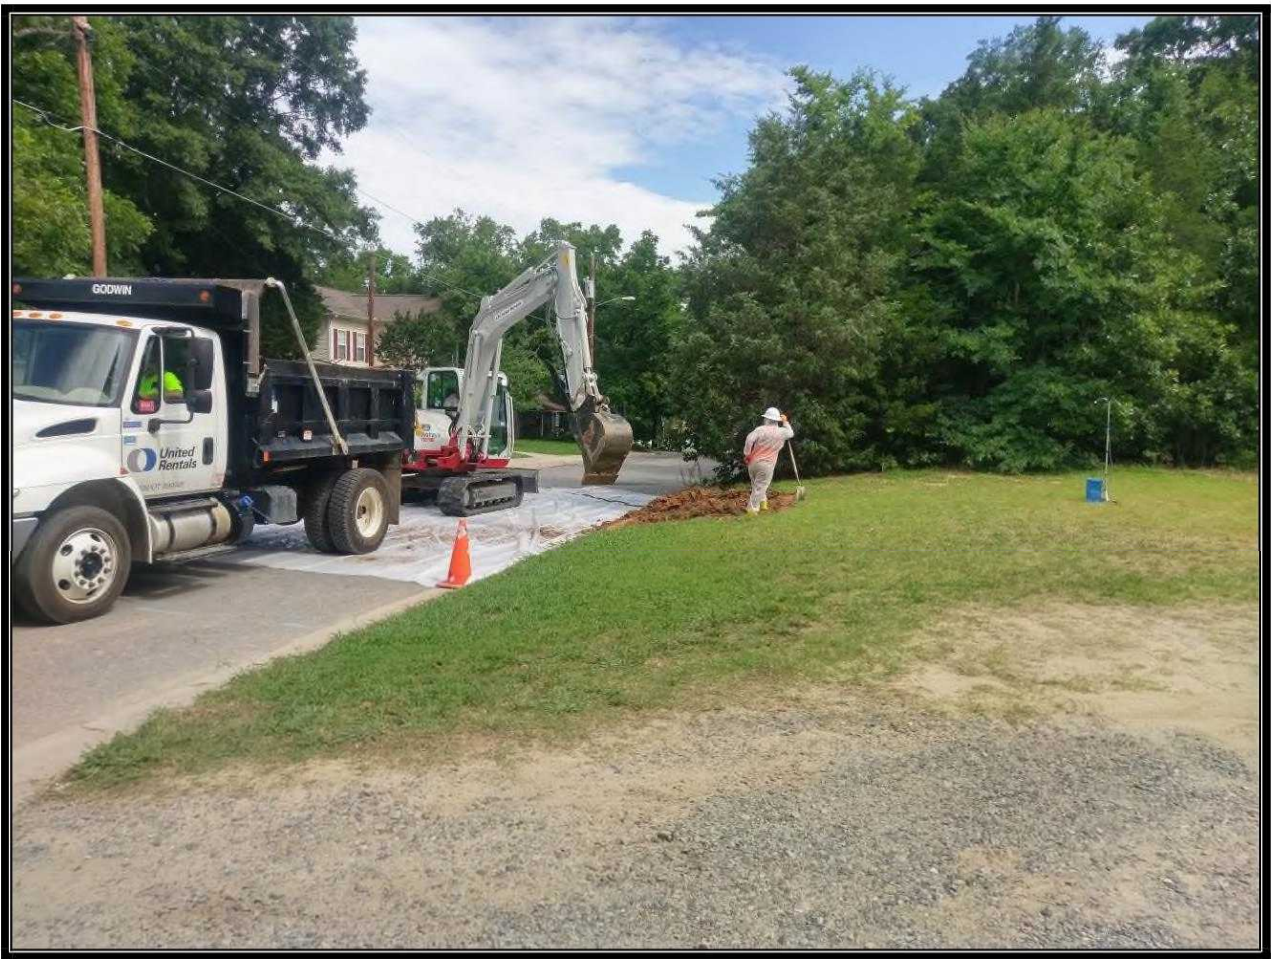
OFFICIAL PHOTOGRAPH NO. 2
U.S. ENVIRONMENTAL PROTECTION AGENCY

Subject: Perimeter air sampling was conducted by a Tetra Tech Superfund Technical Assessment and Response Team (START), State of North Carolina-accredited air monitor, to evaluate the effectiveness of engineering and safety controls in preventing the off-site migration of asbestos fibers during removal activities.

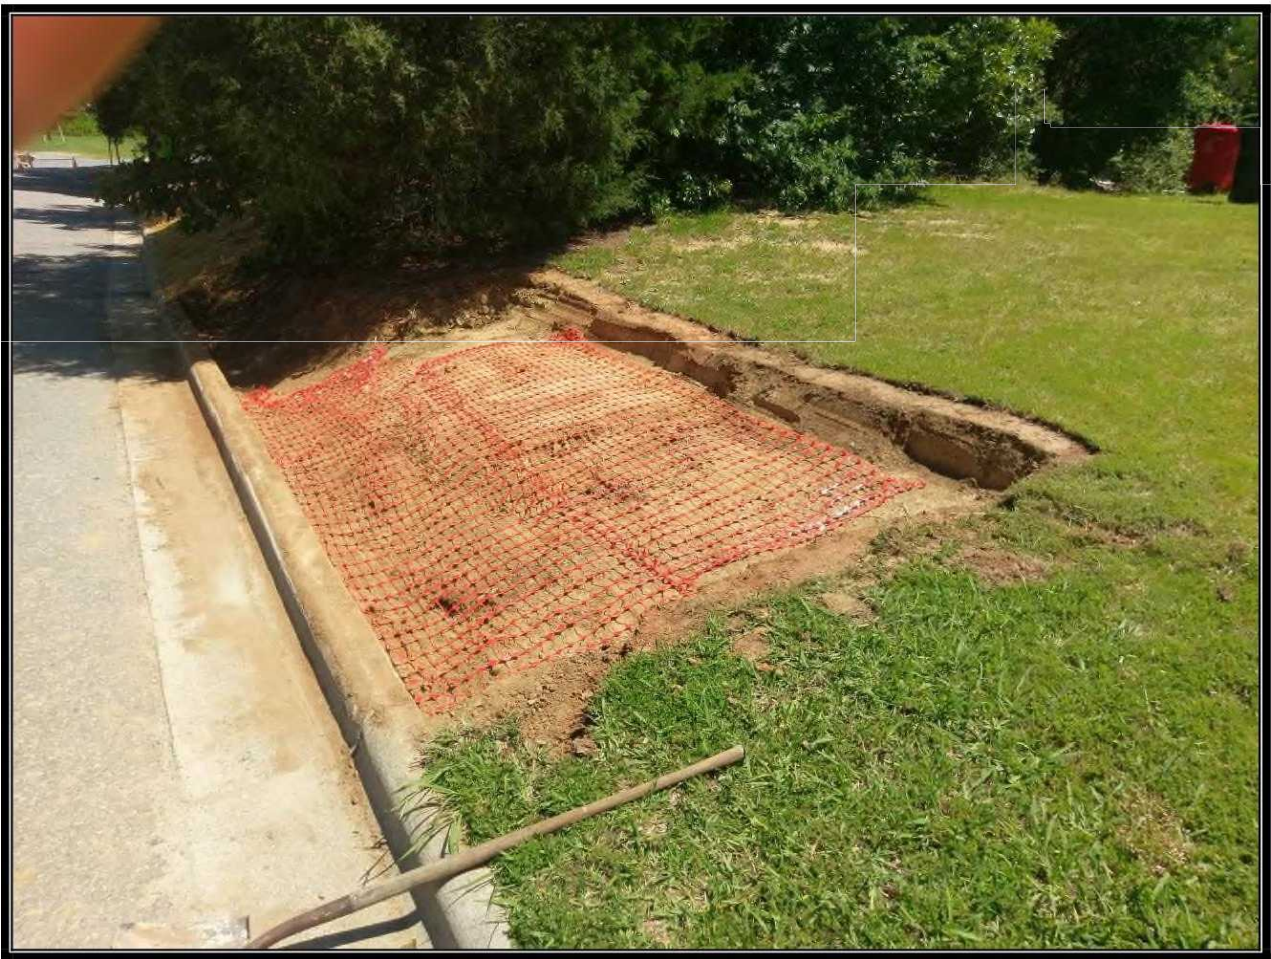
OFFICIAL PHOTOGRAPH NO. 3
U.S. ENVIRONMENTAL PROTECTION AGENCY

Subject: ER installed snow fencing along the subsurface of the excavated area after the visual inspection conducted by Tetra Tech START, State of North Carolina-accredited asbestos inspector and air monitor, detected no visible ACM in the excavated area.

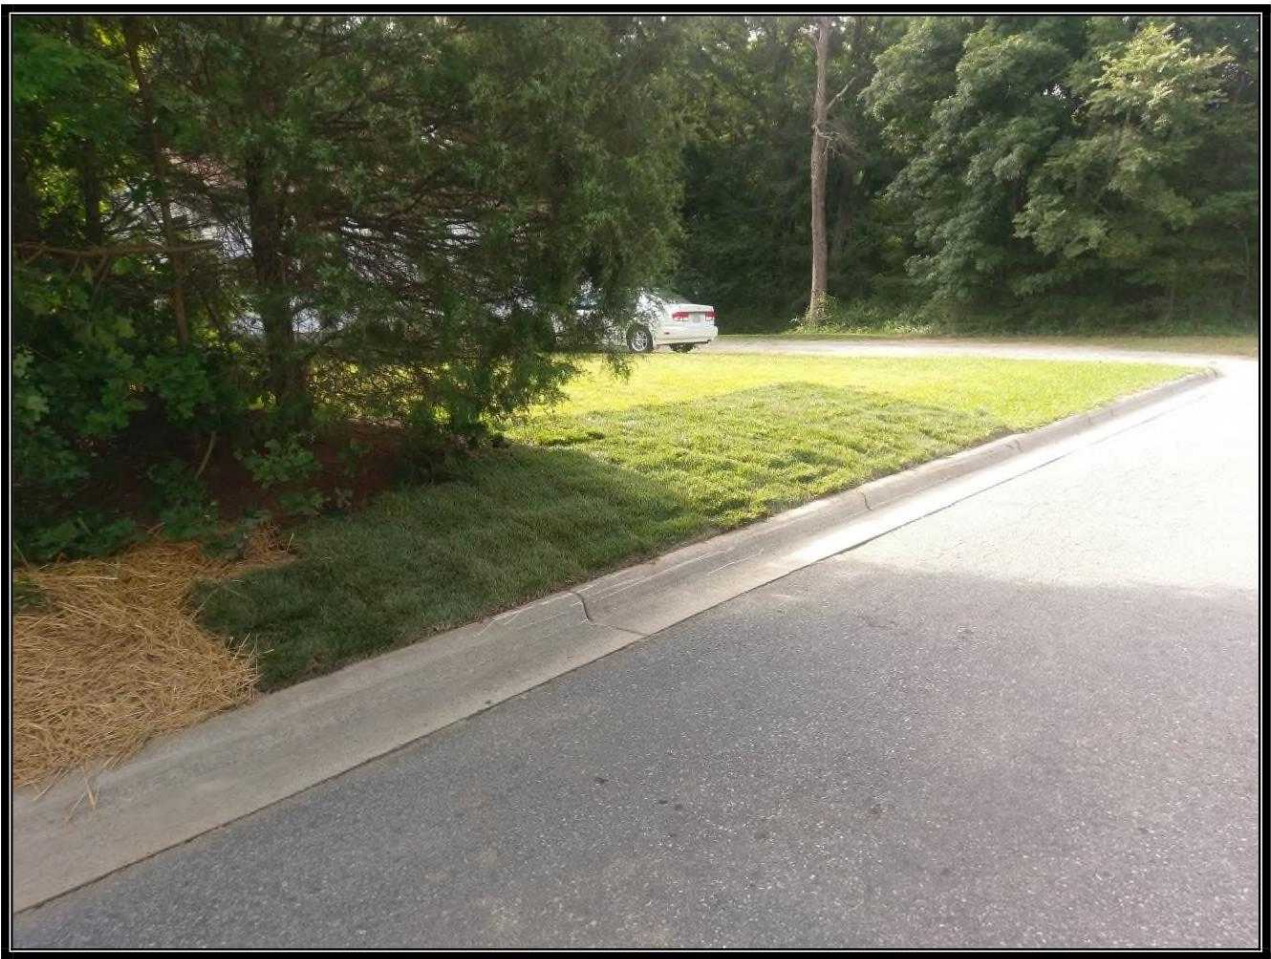
TDD Number:	TT-01-071	Location:	Davidson Asbestos
Orientation:	Southeast	Date:	June 16, 2017
Photographer:	Paul Prys, Tetra Tech	Witness:	None
Subject:	ER installed sod in the excavated areas after backfill and top soil were in place.
